August 2009 in-depth inspection shows further repair needed on Milton-Madison Bridge *Little change seen from January 2009 inspection report*

LOUISVILLE, Ky. (September 17, 2009) – A recent in-depth inspection of the US 421 bridge spanning the Ohio River between Milton, Ky., and Madison, Ind., indicates more repair work is needed on the 80-year-old bridge. Intermittent bridge closures may be expected during repair work, but no long-term closures are expected. Repairs to the structure would likely occur in late 2009 or early 2010.

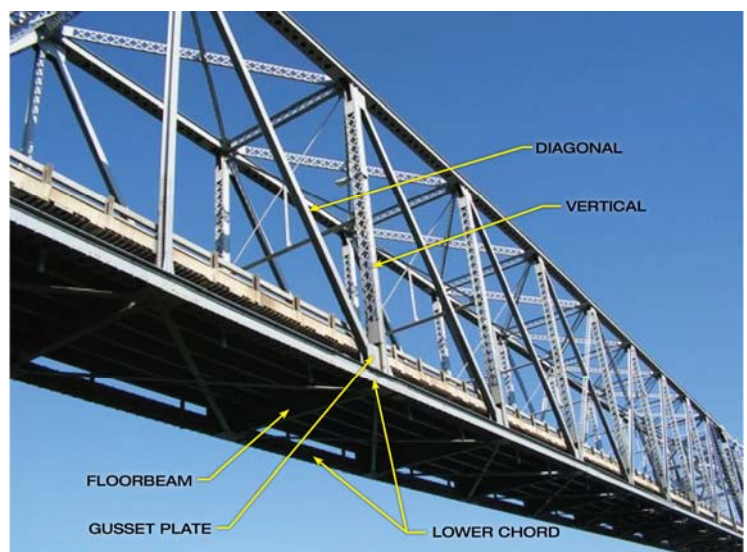
The overall condition of the US 421 bridge was determined to be “poor,” primarily due to the condition of the bridge’s steel truss superstructure, which shows signs of advanced deterioration due to rust and thinning steel. The road deck and substructure were both found to be “satisfactory.”

In the report, inspectors outline needed repairs for the bridge, but recommend that priority be given to repair of gusset plates, which connect diagonal and vertical truss members,

floorbeams and the “lower chord,” which is the steel beam that supports the road deck (see diagram). The report also suggests increased enforcement of a 15-ton weight limit to prevent overweight vehicles from crossing the bridge. The report also outlines other repairs that will require attention in the next six to 24 months.
