Appendix D

CONCEPTUAL REHABILITATION ALTERNATIVE

COMPARISON AGAINST AASHTO GUIDANCE

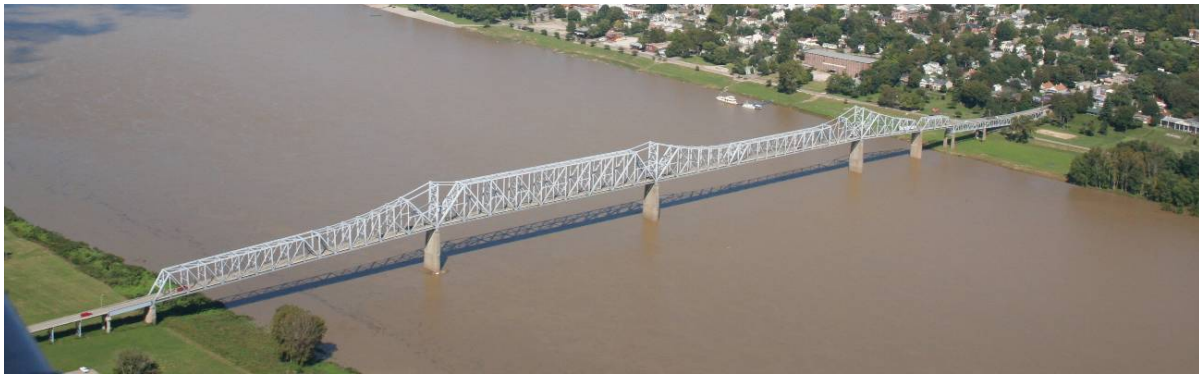
The existing US 421 Milton-Madison Bridge

The existing Milton-Madison Bridge was constructed in 1929 by the J. G. White Engineering company. The steel truss bridge is composed of 18 spans of various types, including cantilever through truss spans, a Baltimore through truss span, Pratt through truss spans, a Pratt deck truss span, a plate girder span, and I-beam spans. It was originally constructed as a toll bridge. According to correspondence from the Indiana and Kentucky State Historic Preservation Offices (SHPO), the bridge represents one of the three earliest bridges built to carry automobiles between the two states, the sole surviving bridge built by J. G. White through the National Toll Bridge Company, and one of the earliest remaining cantilever truss bridges spanning a major river in Kentucky. The bridge is eligible for listing in the National Register of Historic Places under criteria A (events contributing to broad patterns), B (associated with historically significant people) and C (distinctive characteristics of construction technique, period, etc.).

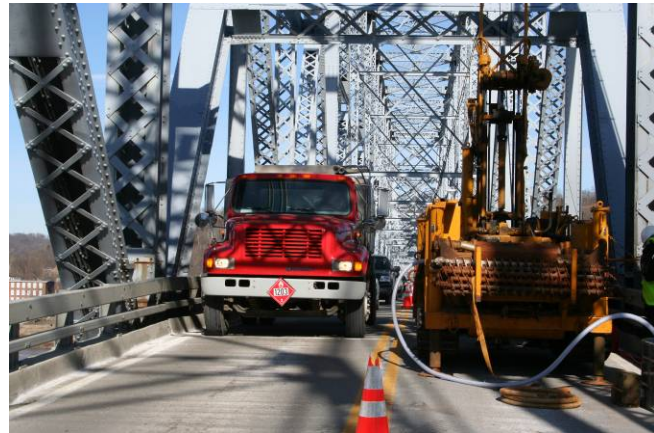
- Narrow Lanes. Two 10-foot lanes are provided, compared to 11-12 feet recommended by AASHTO.
- No shoulders. The existing bridge has no shoulders, compared to the minimum 4 feet recommended by current guidance from AASHTO.

The bridge has two 10 foot lanes

The existing truss superstructure for the US 421 Bridge cannot be rehabilitated and widened to provide adequate travel lane or shoulder widths as identified in the *AASHTO Policy on Geometric Design of Highways and Streets*. The substandard stopping sight distances for the US 421 Bridge cannot be improved to meet minimum stopping sight distances in the *AASHTO Policy on Geometric Design of Highways and Streets* by any bridge rehabilitation.
