Appendix N

CONCEPTUAL REHABILITATION ALTERNATIVE

The existing US 421 Milton-Madison Bridge

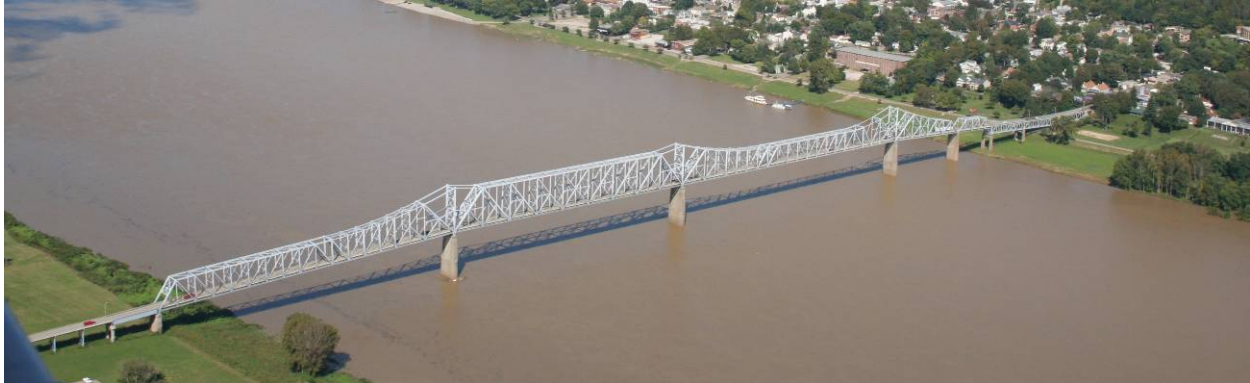
The existing Milton-Madison Bridge was constructed in 1929 by the J. G. White Engineering company. The steel truss bridge is composed of 18 spans of various types, including cantilever through truss spans, a Baltimore through truss span, Pratt through truss spans, a Pratt deck truss span, a plate girder span, and I-beam spans. It was originally constructed as a toll bridge. According to correspondence from the Indiana and Kentucky State Historic Preservation Offices (SHPO), the bridge represents one of the three earliest bridges built to carry automobiles between the two states, the sole surviving bridge built by J. G. White through the National Toll Bridge Company, and one of the earliest remaining cantilever truss bridges spanning a major river in Kentucky. The bridge is eligible for listing in the National Register of Historic Places under criteria A (events contributing to broad patterns), B (associated with historically significant people) and C (distinctive characteristics of construction technique, period, etc.).

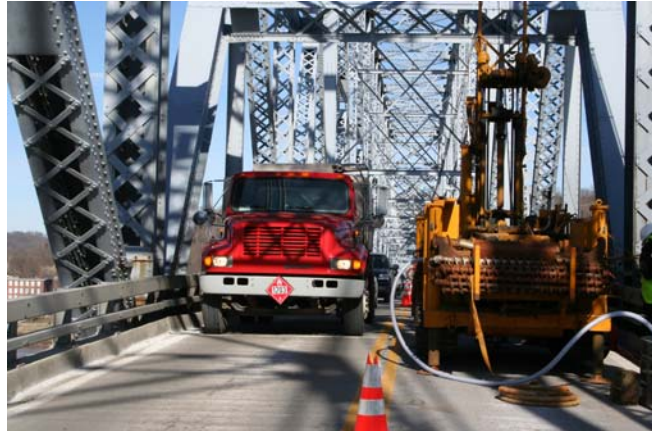
The bridge has two 10 foot lanes

- Narrow Lanes. Two 10-foot lanes are provided, compared to 11-12 feet recommended by AASHTO.
- No shoulders. The existing bridge has no shoulders, compared to the minimum 4 feet recommended by current guidance from AASHTO.
- Inadequate cross-slope. Both Kentucky and Indiana recommend a 2% cross-slope on bridges to drain water away from the centerline. The existing bridge provides a 1% cross-slope.
- Inadequate slope. Segments along the existing bridge are level; both states require a minimum slope of 0.3% to 0.5% to provide adequate drainage on bridges.

The existing truss superstructure for the US 421 Bridge cannot be rehabilitated and widened to provide adequate travel lane or shoulder widths as identified in the *AASHTO Policy on Geometric Design of Highways and Streets*. The substandard stopping sight distances for the US 421 Bridge cannot be improved to meet minimum stopping sight distances in the *AASHTO Policy on Geometric Design of Highways and Streets* by any bridge rehabilitation.
