# Appendix D

## Description of the Proposed Action

### D.1 Cross-Section

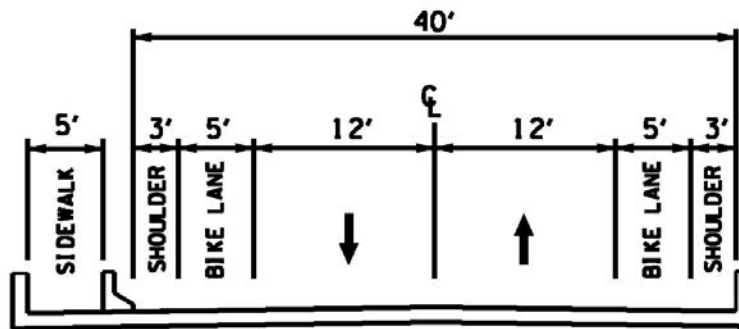
Figure D.2 – Proposed Bridge Cross-Section

The Proposed Action would provide a 40-foot river crossing, consisting of two 12-foot wide lanes with full 8-foot shoulders. A 5-foot wide sidewalk would be cantilevered off one side of the structure. **Figure D.2** illustrates the cross-section for the river bridge. The 5-foot bike lanes along the roadway are included in the 8-foot wide shoulders.

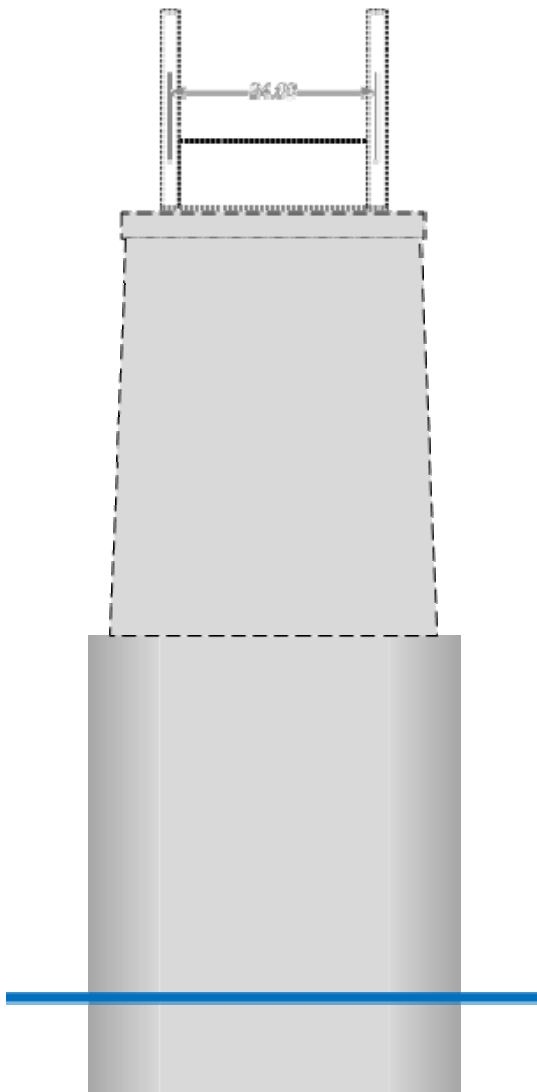
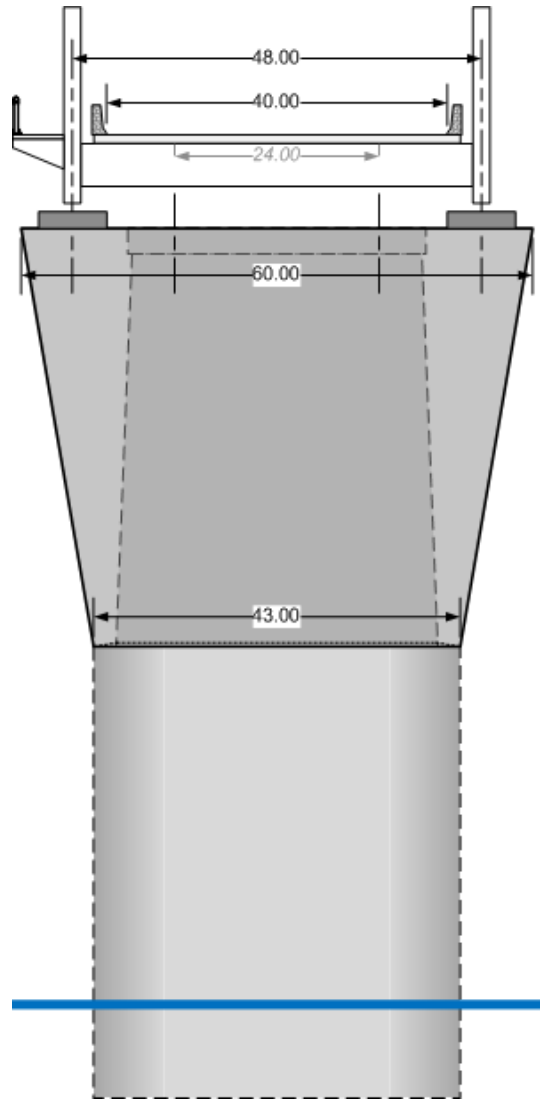
**Figure D.3**  
Pier Widening Activities

Existing Pier

Proposed  
New Pier

Based on this pier analysis, the other river piers (piers 6, 7, and 8) could be reused as the substructure for a new river crossing but would require strengthening and widening. Pier 5 is not recommended for reuse and may be eliminated to reduce uplift forces. To ensure the piers are adequate to withstand lateral loads (e.g. wind loadings and barge impacts), the pier foundations would have to be retrofitted. While analysis is still underway to determine the most appropriate mitigation measures, this could include scour mitigations and/or strengthening measures like increasing the size of the foundations or drilling shafts to add stability. The bridge would remain open to traffic throughout the pier mitigation construction activities.

In addition, the existing piers would also need to be widened to support the wider superstructure. Although details will be determined during final design stages, the existing piers would be encased in new concrete that would flare wider at the top than in the current conditions. Preliminary checks of the pier shafts indicate that the section is under reinforced for some of the bending loads and may require additional reinforcement. Pier reconstruction would begin early in the construction sequence, prior to the closure of the bridge, to minimize the length of time the bridge would be closed to traffic. **Figure D.3** shows a conceptual drawing of the necessary pier widening that would be required to support the wider superstructure.

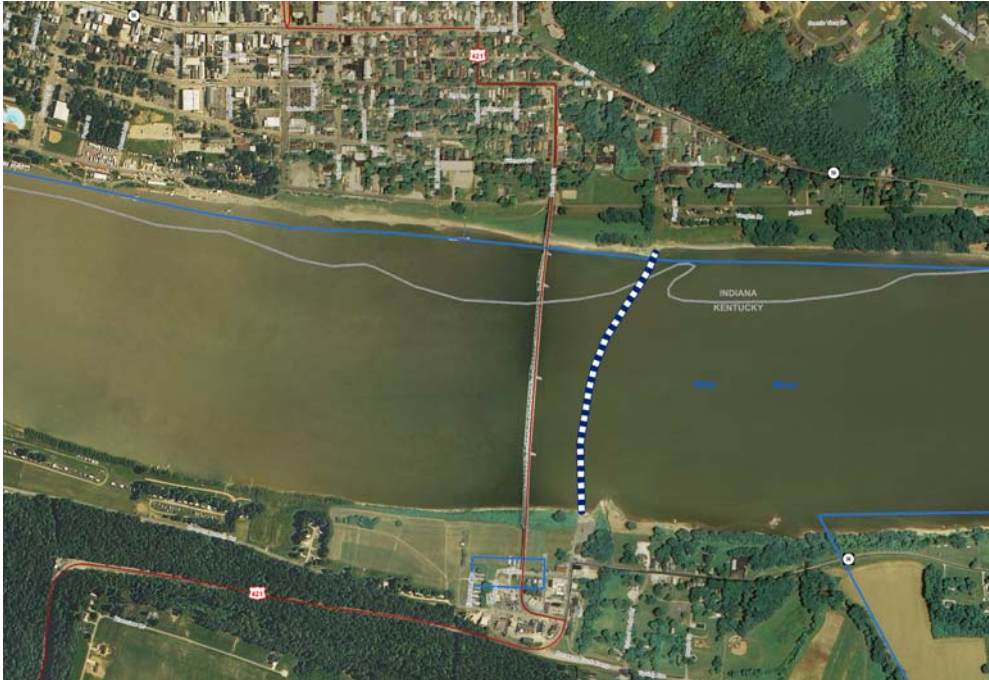
Figure D.4 –Ferry Routing

To maintain travel between the two communities, the project team would provide a ferry service across the river that would operate for the duration of the bridge closure. Although many of the operational details would be arranged by the contractor, the service will run between the boat ramp in Milton east of the bridge the former Ferry Street boat ramp in Madison. **Figure D.4** shows the likely route the ferry service would take.

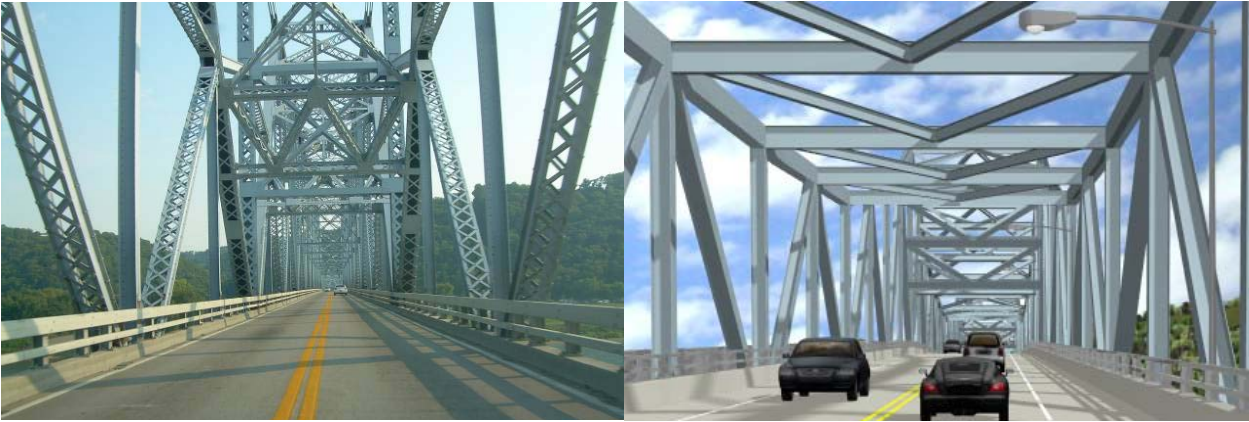
**Figure D.7 – View along Highway crossing Bridge**

Shown in **Figure D.7**, the new bridge would appear wider than the existing; the cross-sectional width of the highway increases from 20 feet to 40 feet in this scenario. A view along the existing truss is shown on the left; the rendering of the proposed bridge is on the right. Although the contractor will determine final design details, the new superstructure would appear less complex than the existing truss.

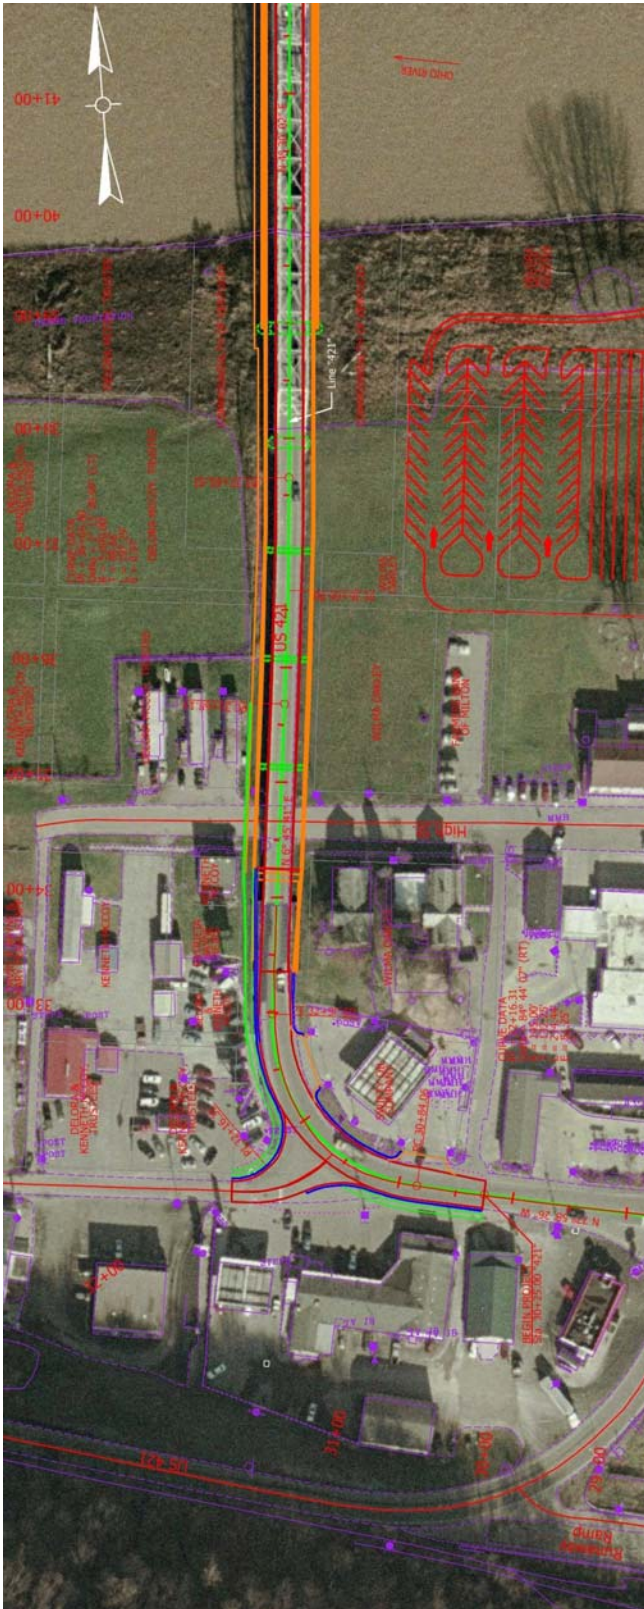
**Figure D.5**  
Kentucky Approach

The Kentucky approach, illustrated in **Figure D.5**, extends approximately 100 feet from the abutment. An abutment and four new piers would be constructed on the Kentucky shore, replacing the existing piers. The existing clearance over High Street would be preserved.

A sidewalk would be cantilevered to the downstream side of the bridge in this scenario. The sidewalk would cross the river and descend to ground level via a series of ADA-compliant ramps located near the riverfront in Milton, west of the structure. A connection to the east and south would provide connectivity to the sidewalk along Ferry Street.

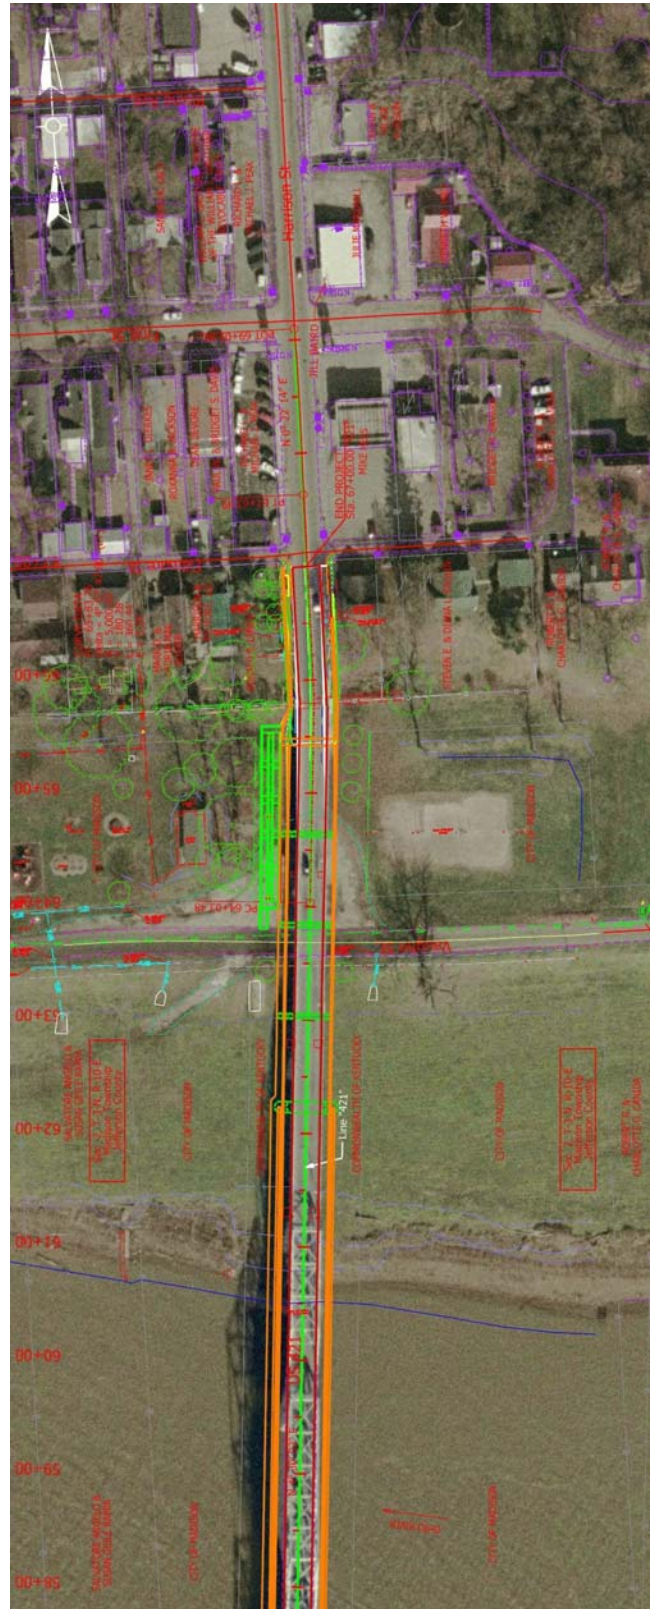
**Figure D.6**  
Indiana Approach

The Indiana approach, illustrated in **Figure D.6**, extends approximately 100 feet north from the bridge abutment. A larger abutment and four new piers would be constructed on the Indiana shore, replacing the existing land piers.

A sidewalk would be cantilevered to the downstream side of the bridge in this scenario. The sidewalk would cross the river and run along the western side of the new bridge approach, looping to the west with an ADA-compliant ramp that ties into Vaughn Drive near Jaycee Park in Madison. Alternately, a sidewalk extension could continue north along Harrison Street to connect into the existing sidewalk network there.

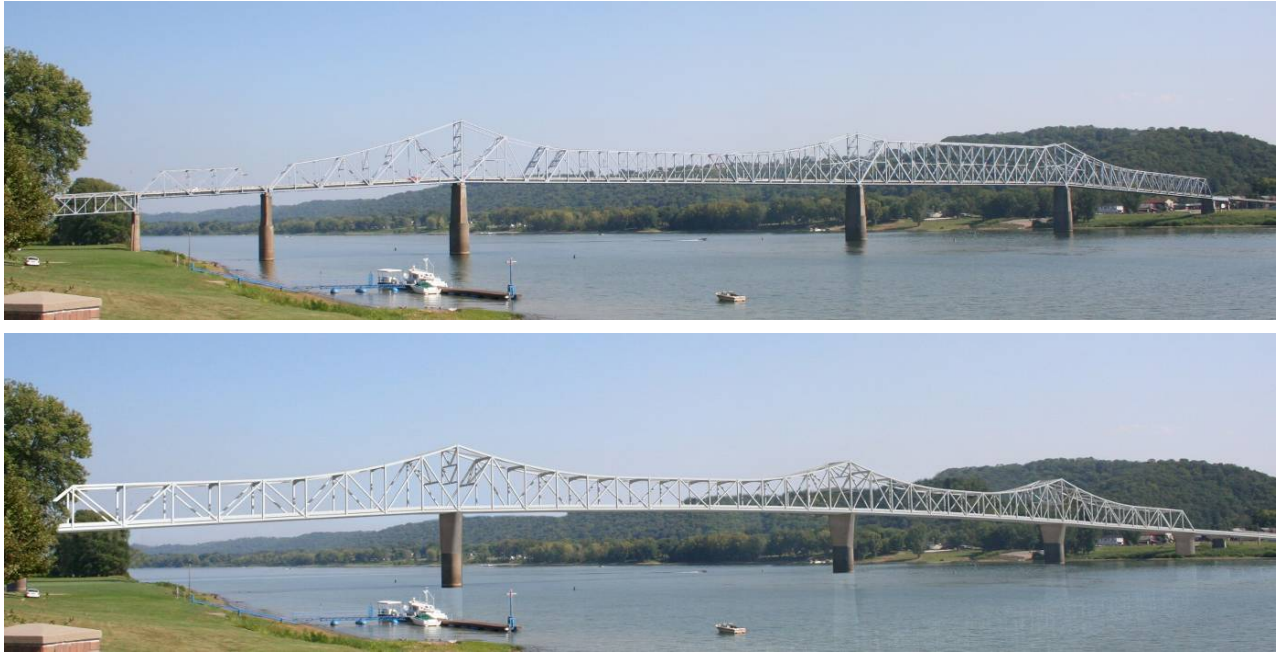
**Figure D.8 – View from Madison Riverfront**

**Figure D.8** shows a comparison of the view towards the bridge from the Madison riverfront. This is a representative illustration of the viewshed from riverfront properties within the National Historic Landmark. The existing bridge is shown on the top; a rendering of the Superstructure Replacement truss is shown on the bottom.

From this perspective, the differences in the size and complexity between the two structures are less apparent. The viewshed from the National Historic Landmark would be largely unchanged. Modifications to the piers would be visible but the general appearance remains similar to the current arrangement and pier type.

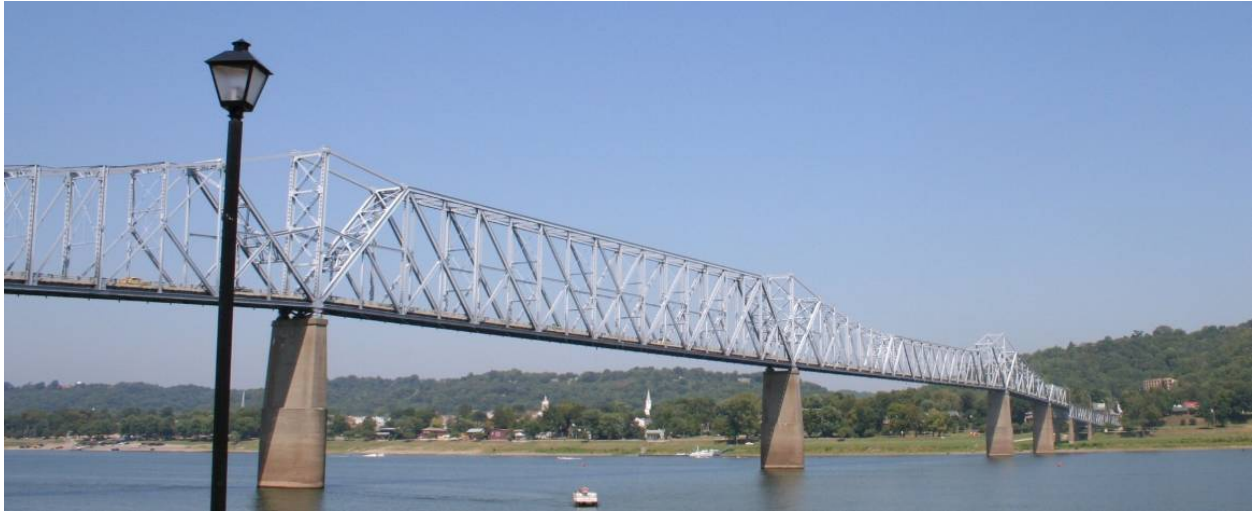
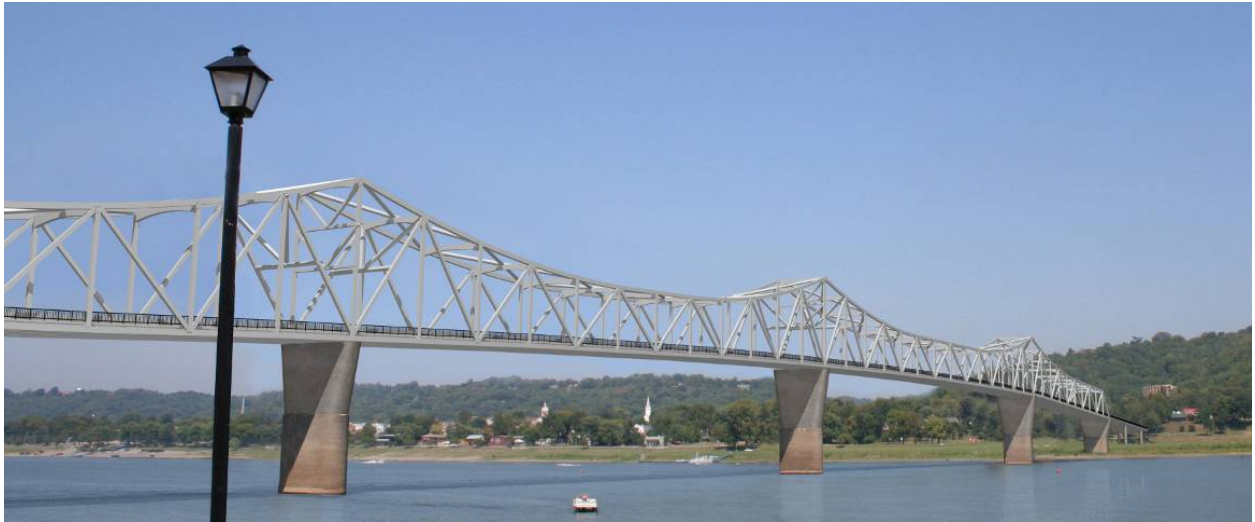
**Figure D.9 – View from Milton Boat Ramp**

**Figure D.9** shows a comparison of the views from the Milton boat dock, east of the existing bridge. This view also presents historic downtown Madison, visible beyond the structure. The existing bridge is shown on the top; a rendering of the Superstructure Replacement truss is shown on the bottom.
